Report of Geotechnical Engineering Services:

2026 North Valley Road Improvement Project
From NE Ribbon Ridge Road to NE Albertson Road
Yamhill County, Oregon

Central Project: YamhillCo-1-01

Date: January 15, 2026

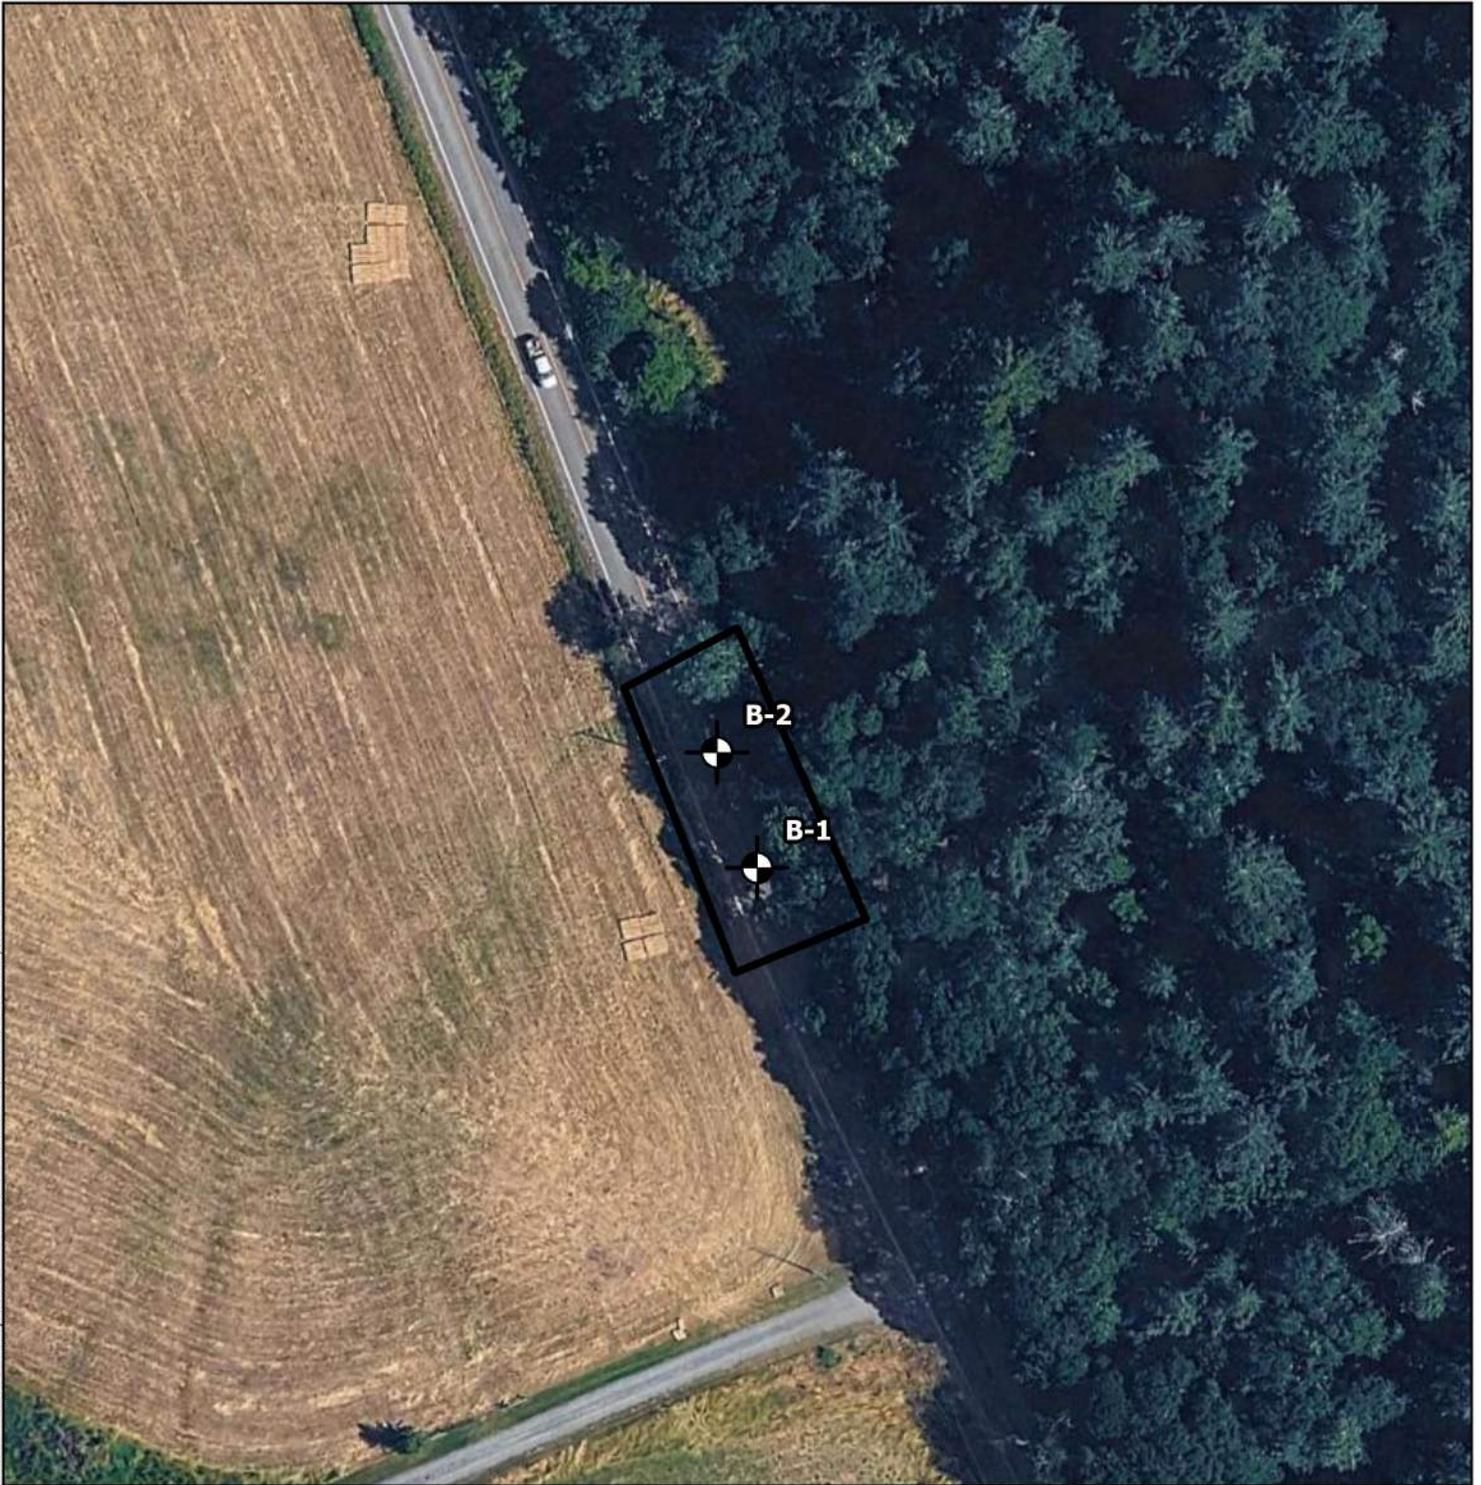
Figure-2A

Soil conditions at uneven area 1 consist of black to brown and gray clay (CH). Based on Standard Penetration Test (SPT) blow counts, the consistency of the clay is primarily medium-stiff to stiff. Conversely, we observed soft to very-soft clay in boring B-2 at a depth of 15 feet bgs. Potential fill consisting of clay with trace angular gravel is below the aggregate base in boring B-2 extending to approximately 4 feet bgs. The potential fill is likely associated with construction of the road's embankment.

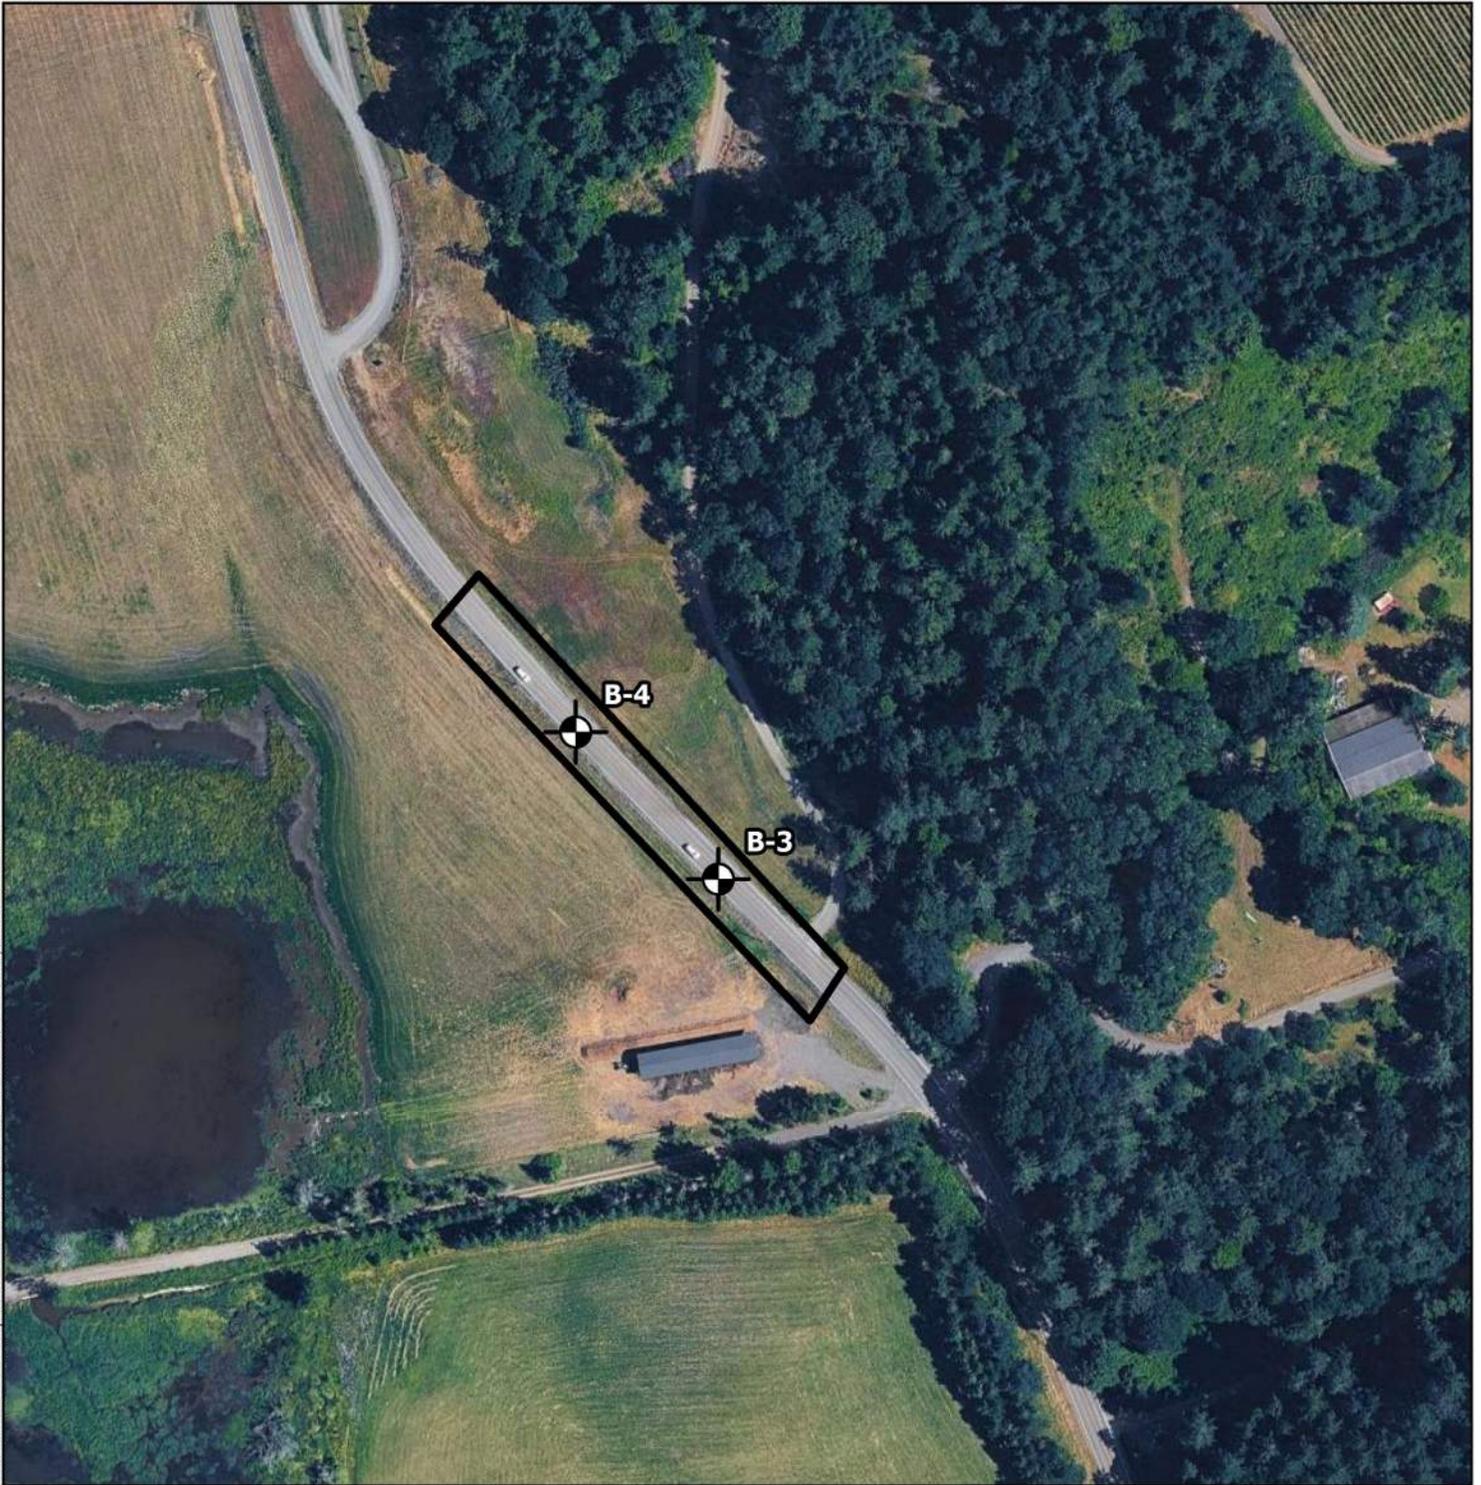
CENTRAL GEOTECHNICAL SERVICES, LLC	Figure-2B

Soil conditions at uneven area 2 consist of black to brown clay (CH). The results of Atterberg Limit testing indicate that the clay is highly plastic based on a Plasticity Index (PI) of 71. SPT blow counts indicate the consistency of the clay is primarily medium-stiff to stiff with a very-soft to soft layer in B-4 at around 7 to 12 feet bgs.

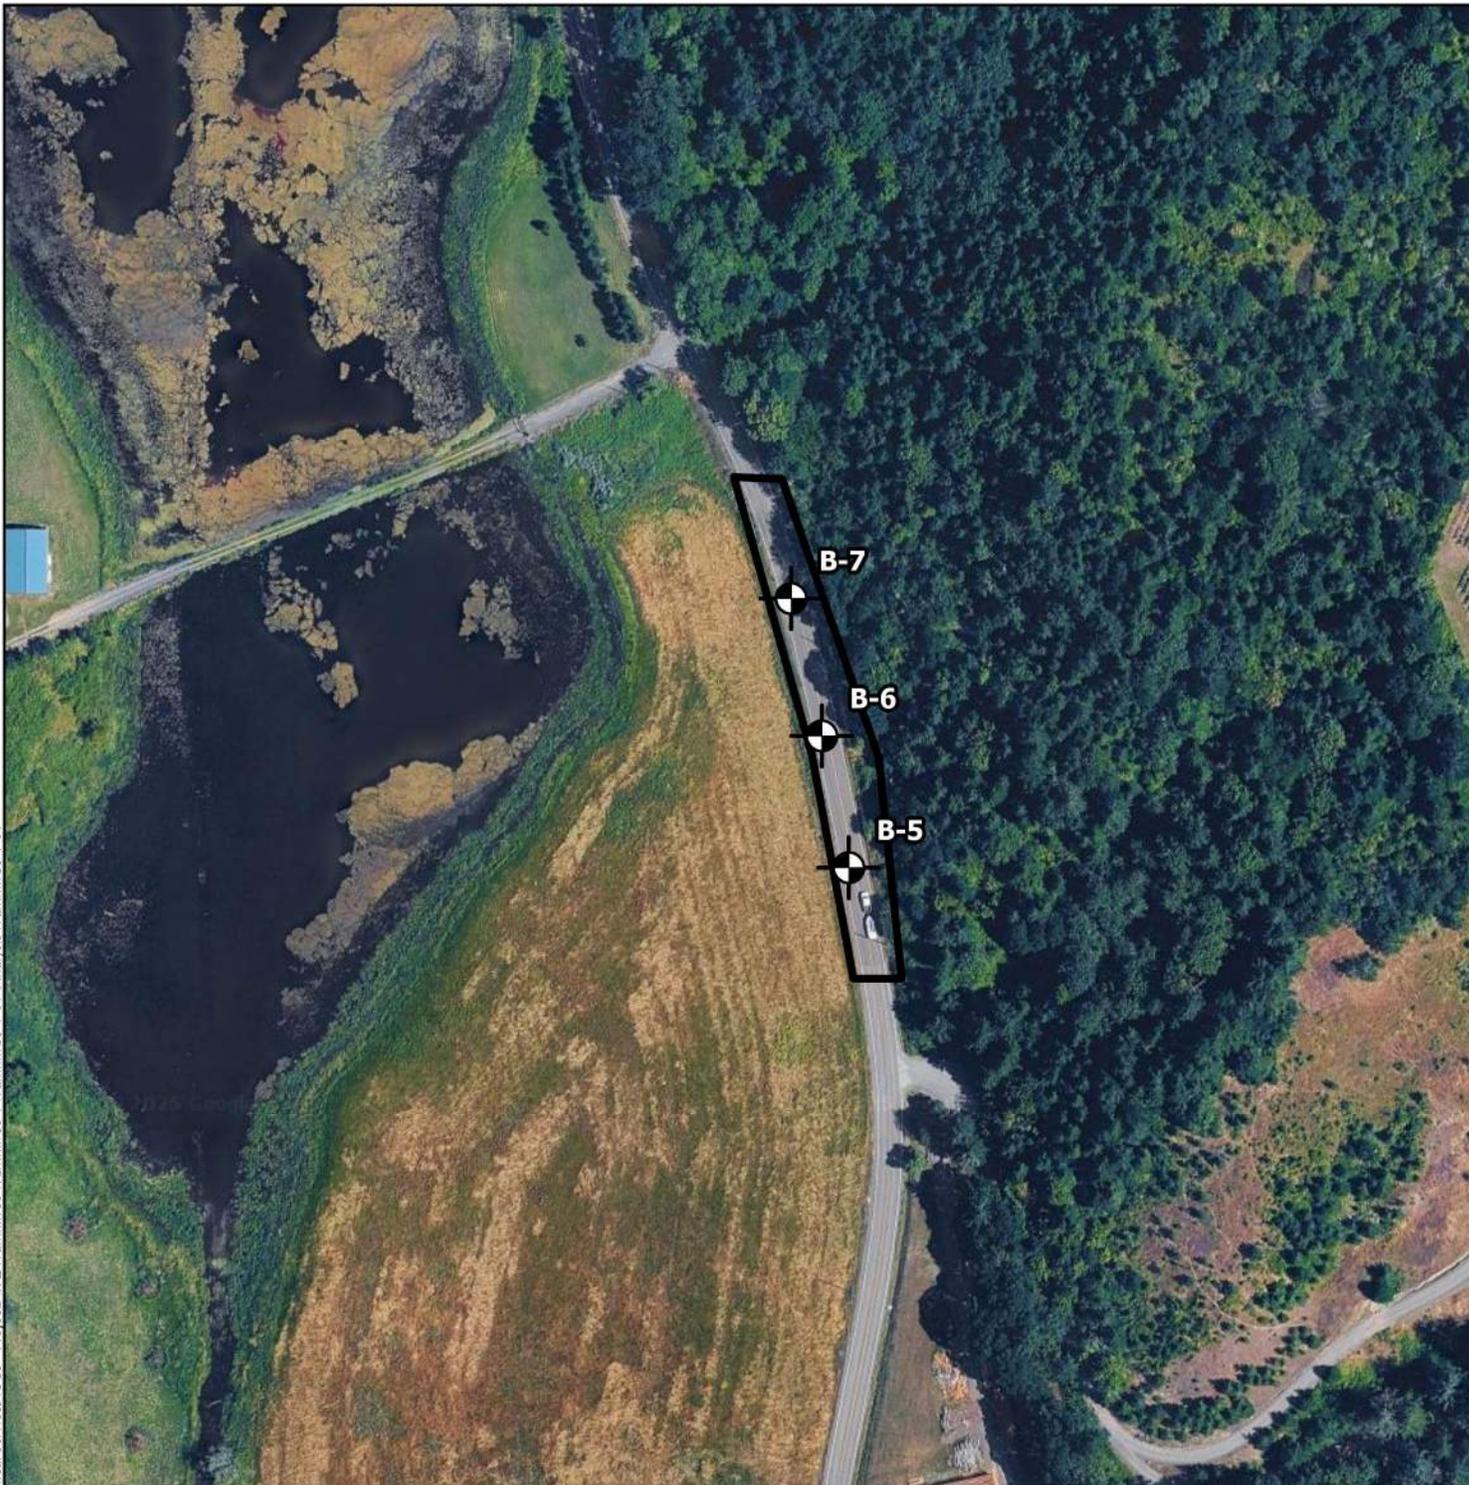
CENTRAL GEOTECHNICAL SERVICES, LLC	Figure-2C

Soil conditions at uneven area 3 consist of gray to dark gray clay (CH) and silt (MH). The results of Atterberg Limit testing indicate that the clay is highly plastic based on Pls of 58 and 66. SPT blow counts indicate the consistency of the clay and silt is primarily medium-stiff to stiff with some SPT blow counts indicating soft to medium-stiff consistency at varying depths between 5 and 10 feet bgs.

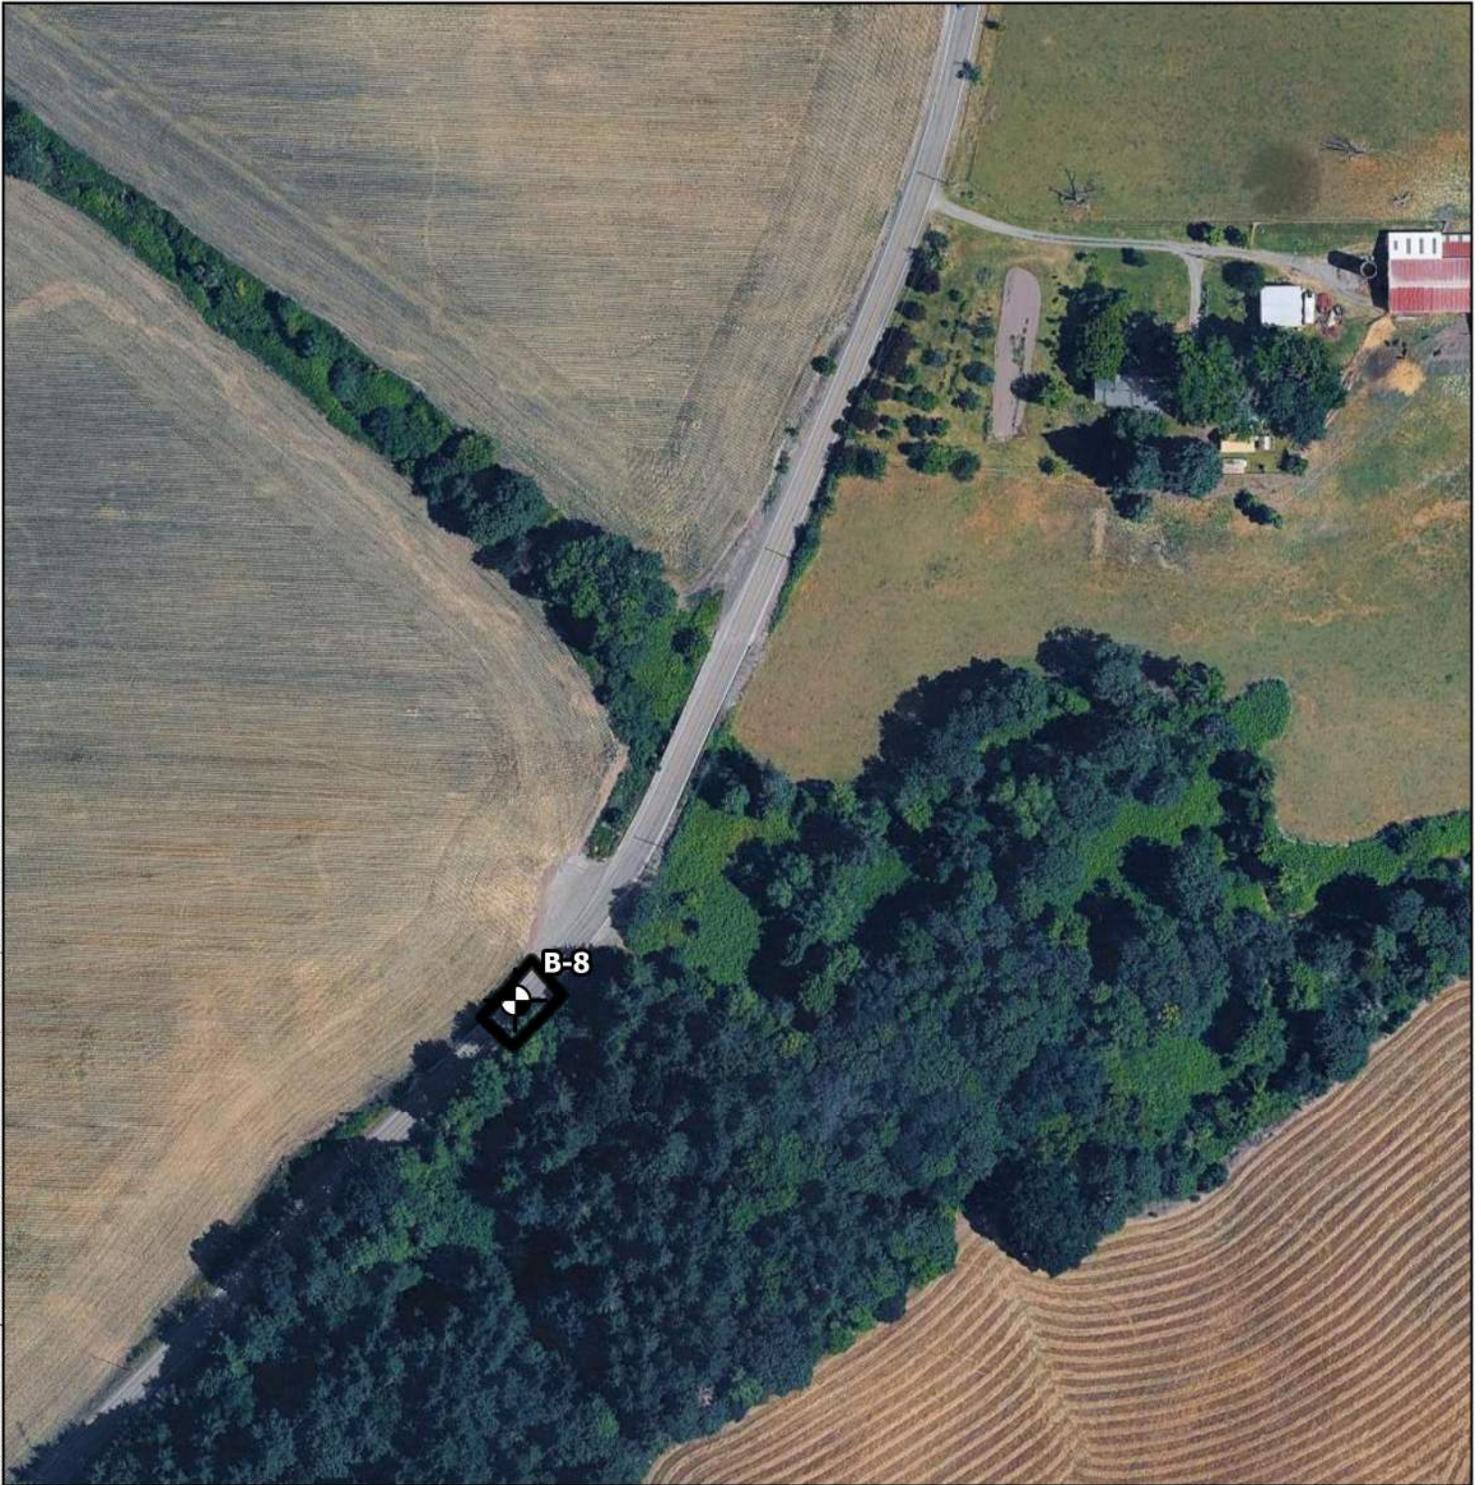
Soil conditions at uneven area 4 consist of gray clay (CH). Based on SPT blow counts, the consistency of the clay is soft directly below the aggregate base and grades to primarily medium-stiff to stiff. The results of Atterberg Limit testing indicate that the clay is highly plastic based on a PI of 81.

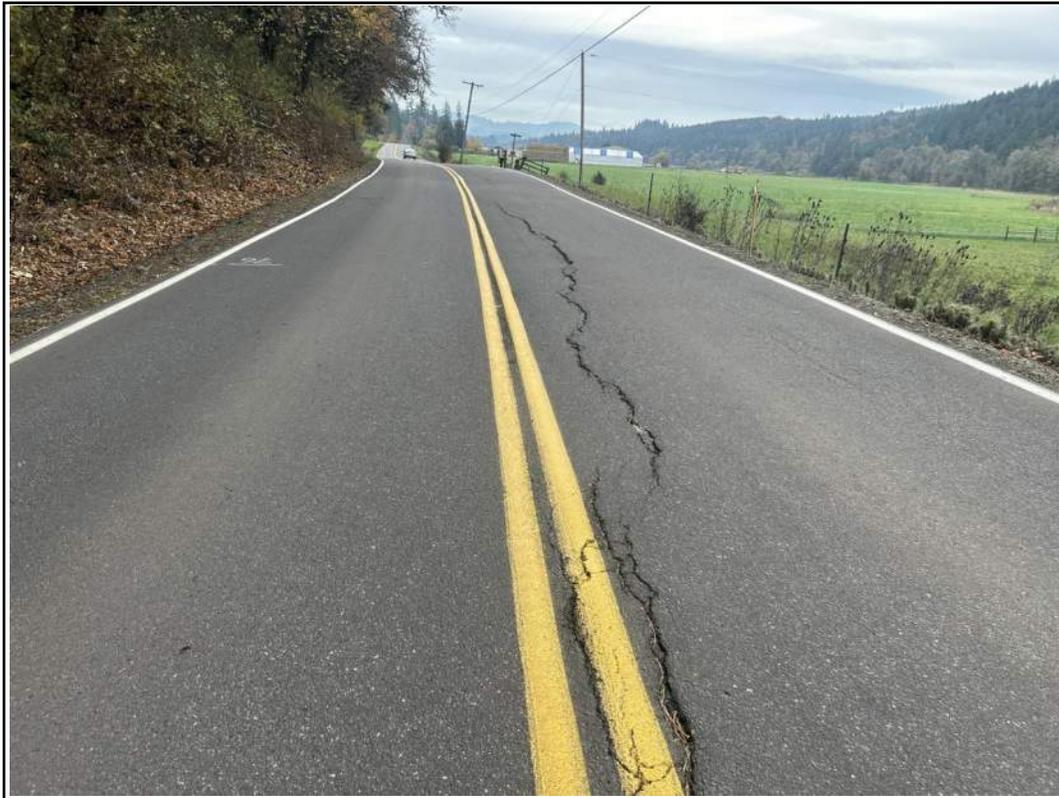
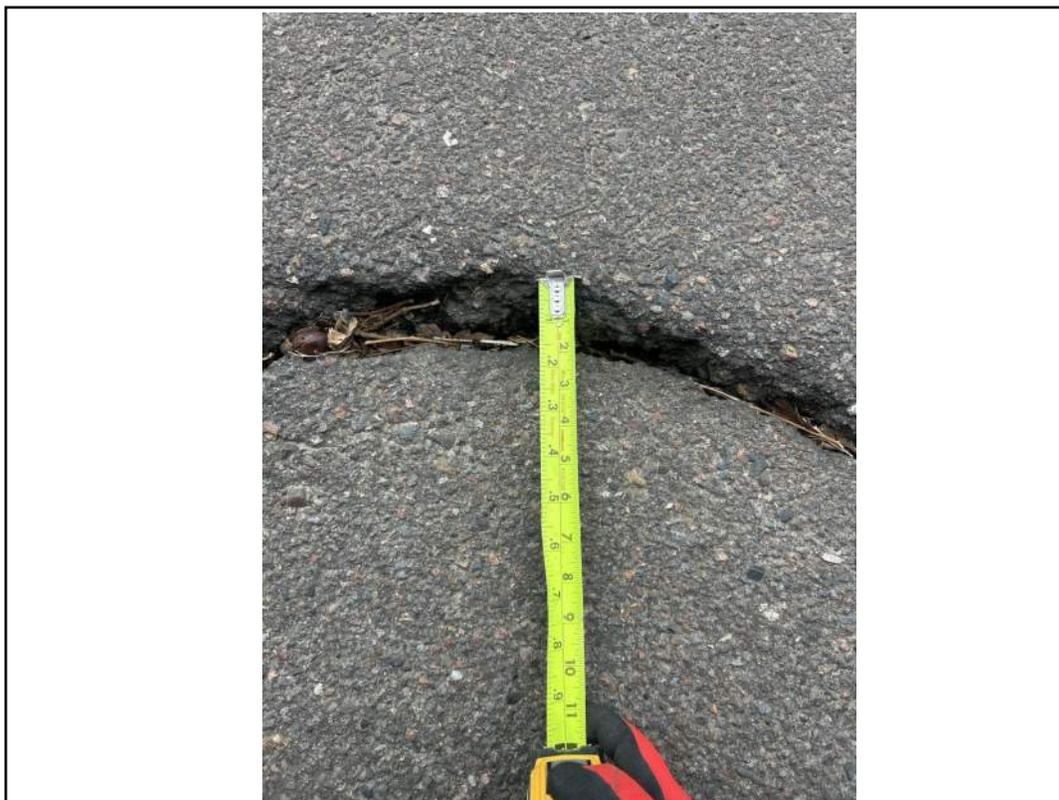
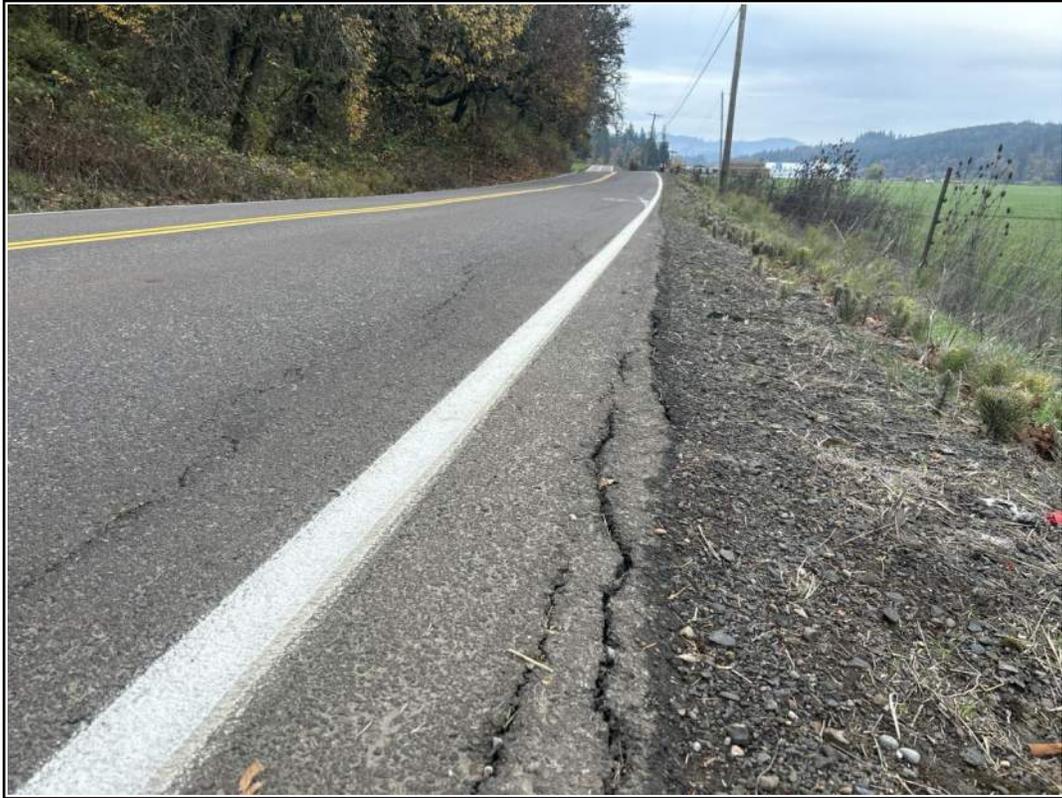
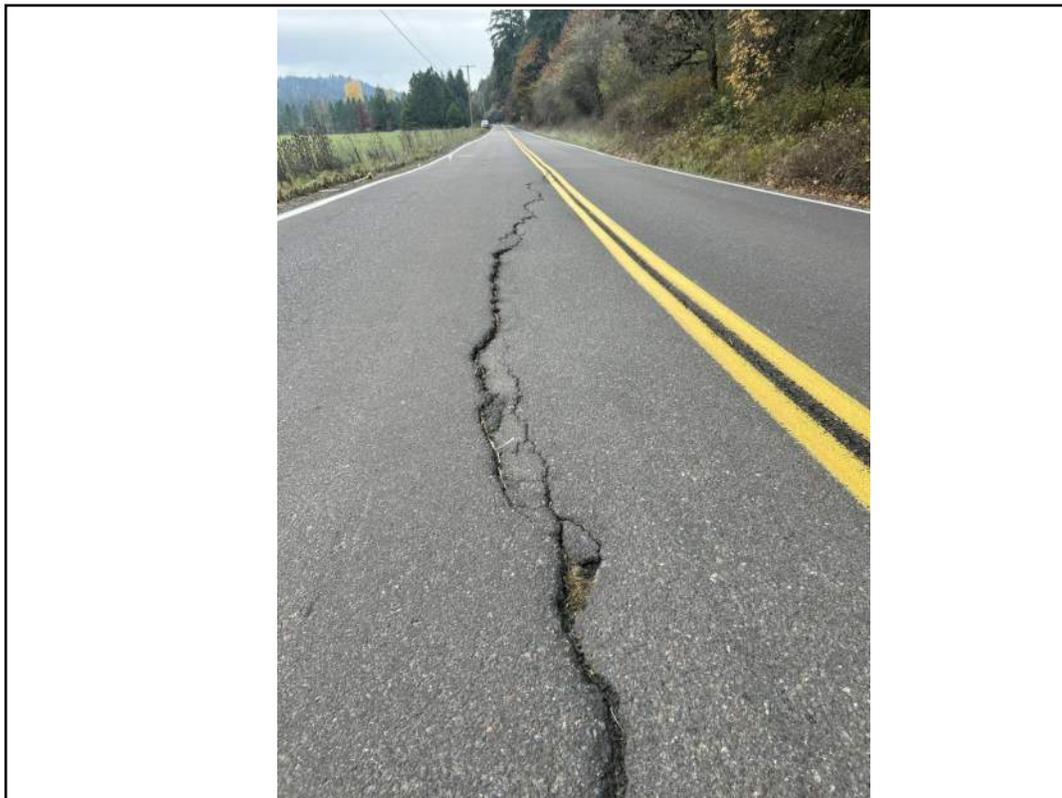
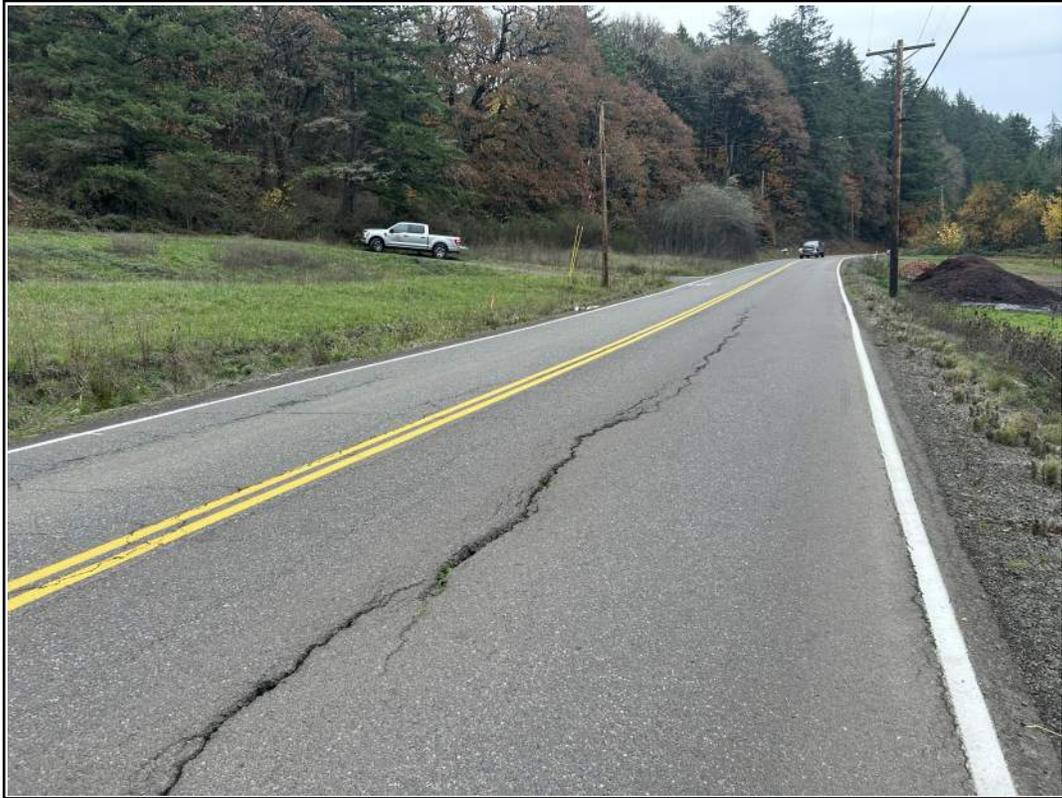
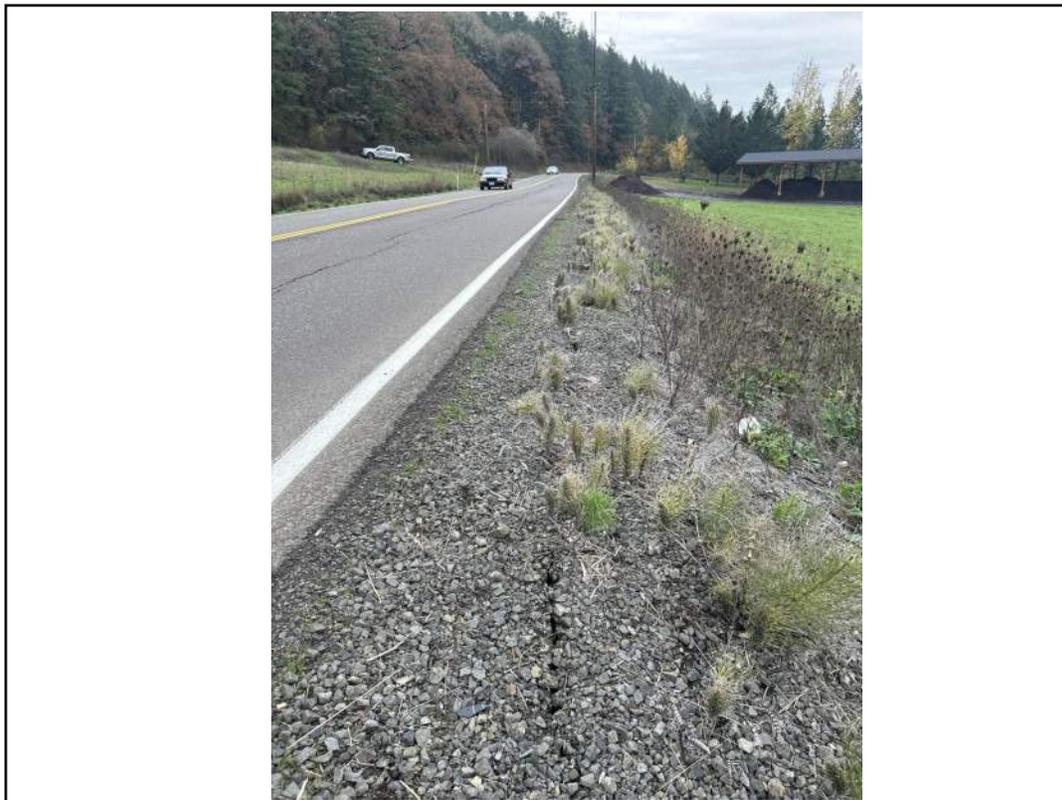
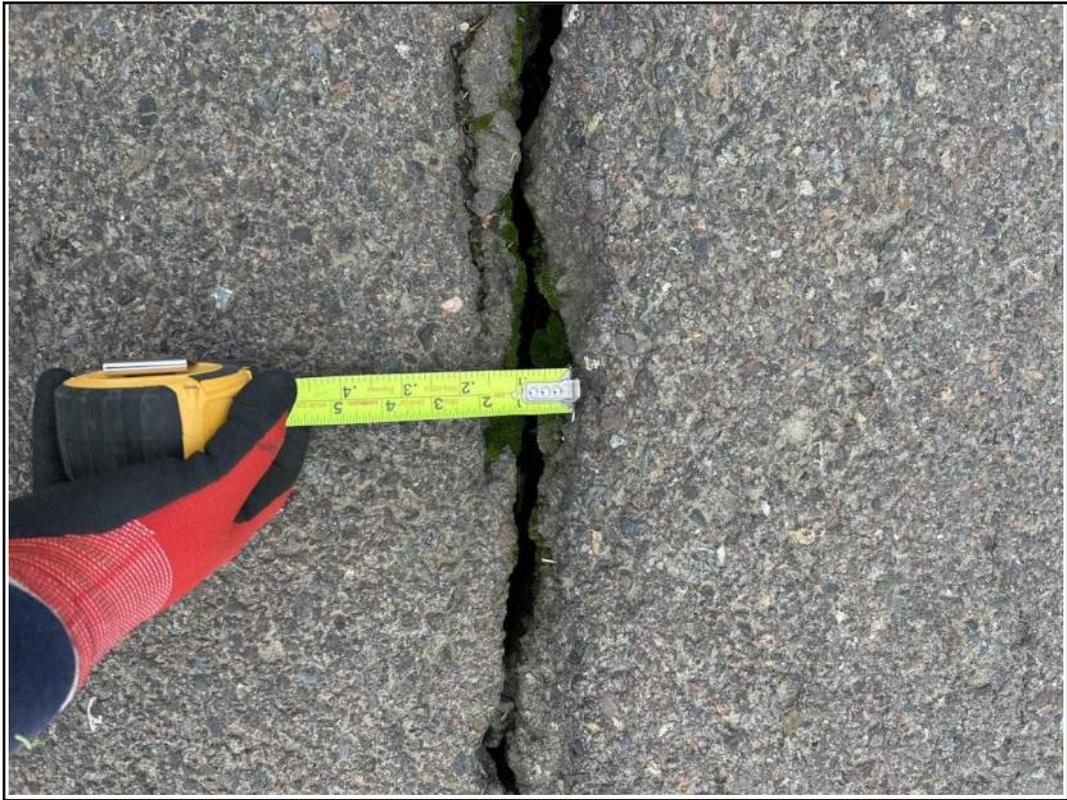
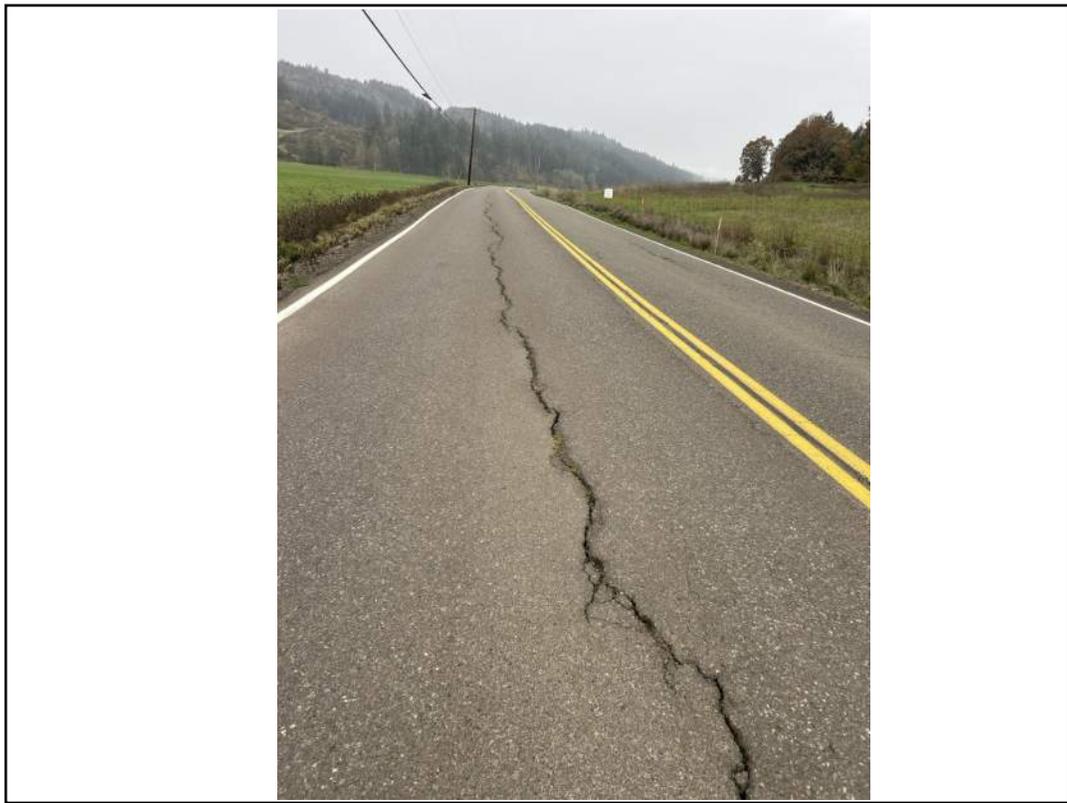
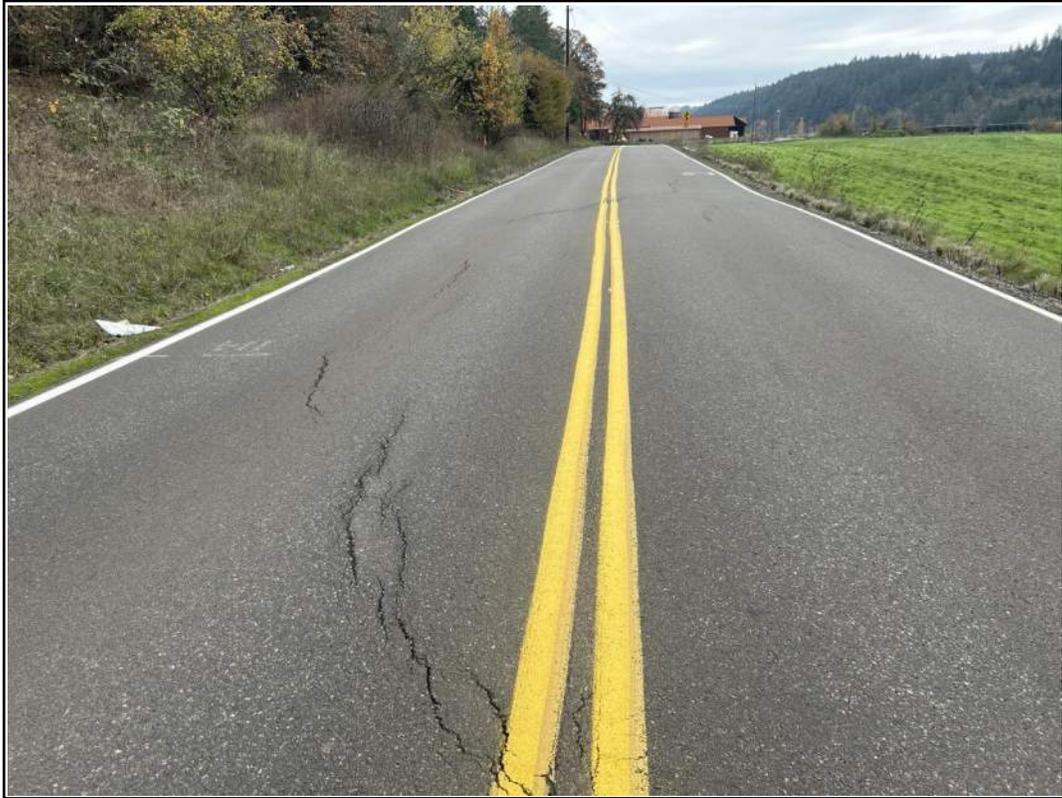
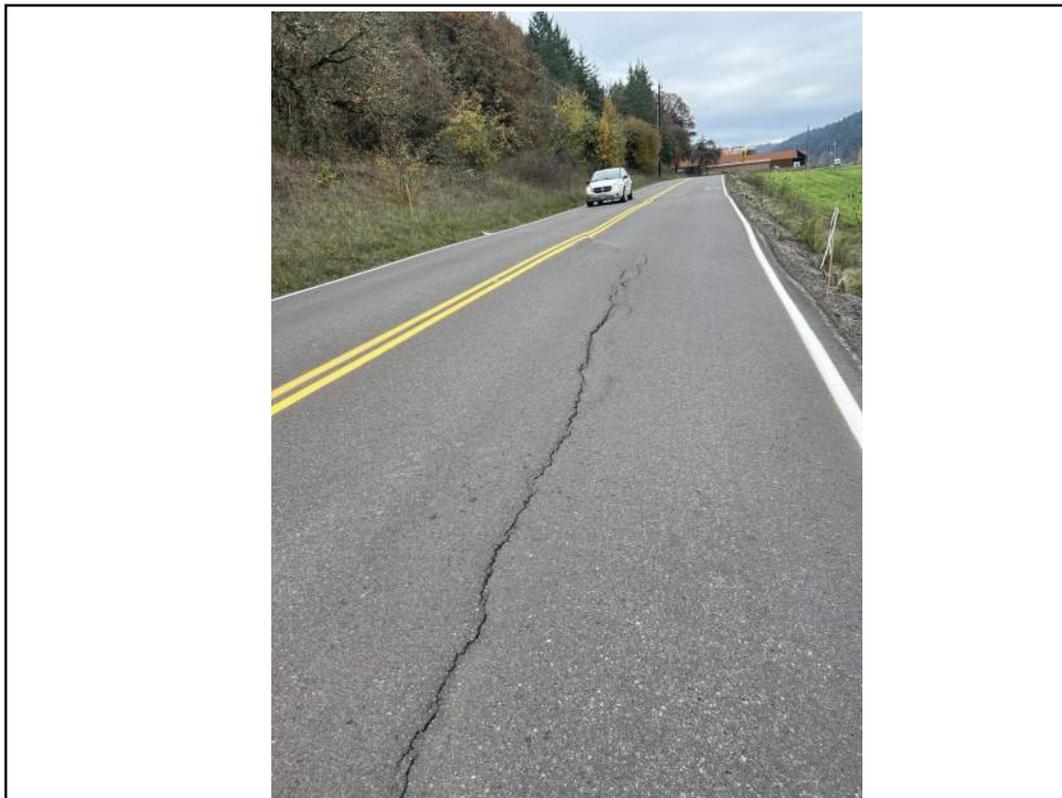
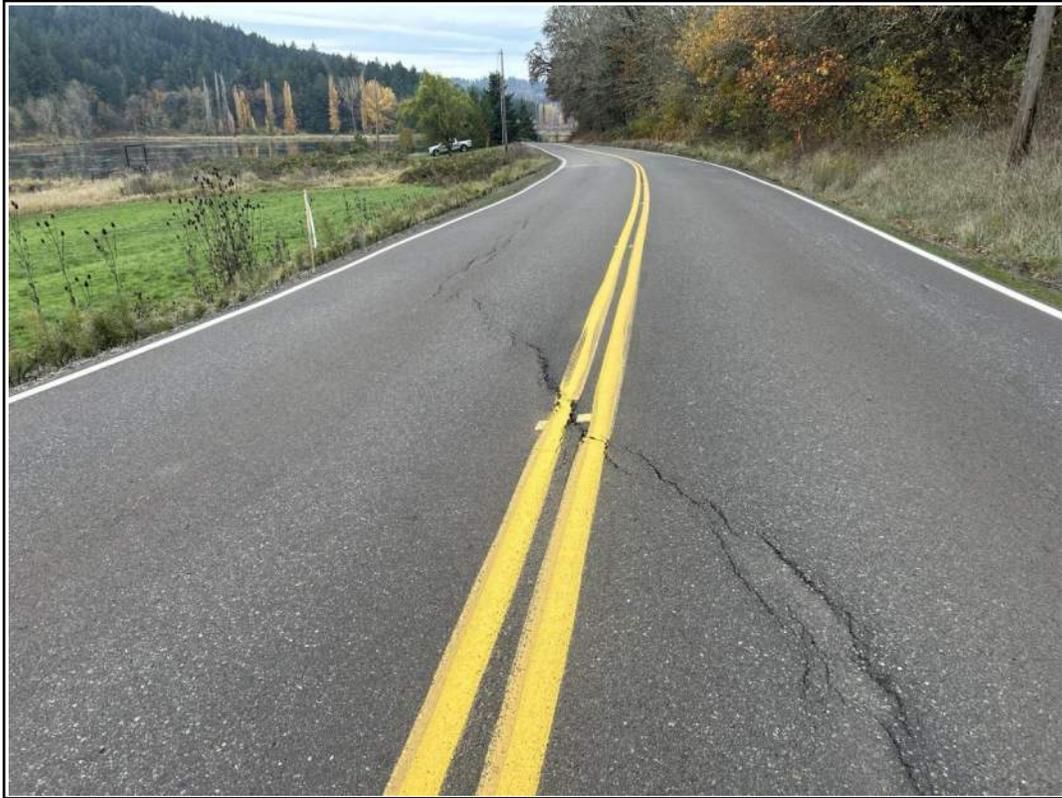
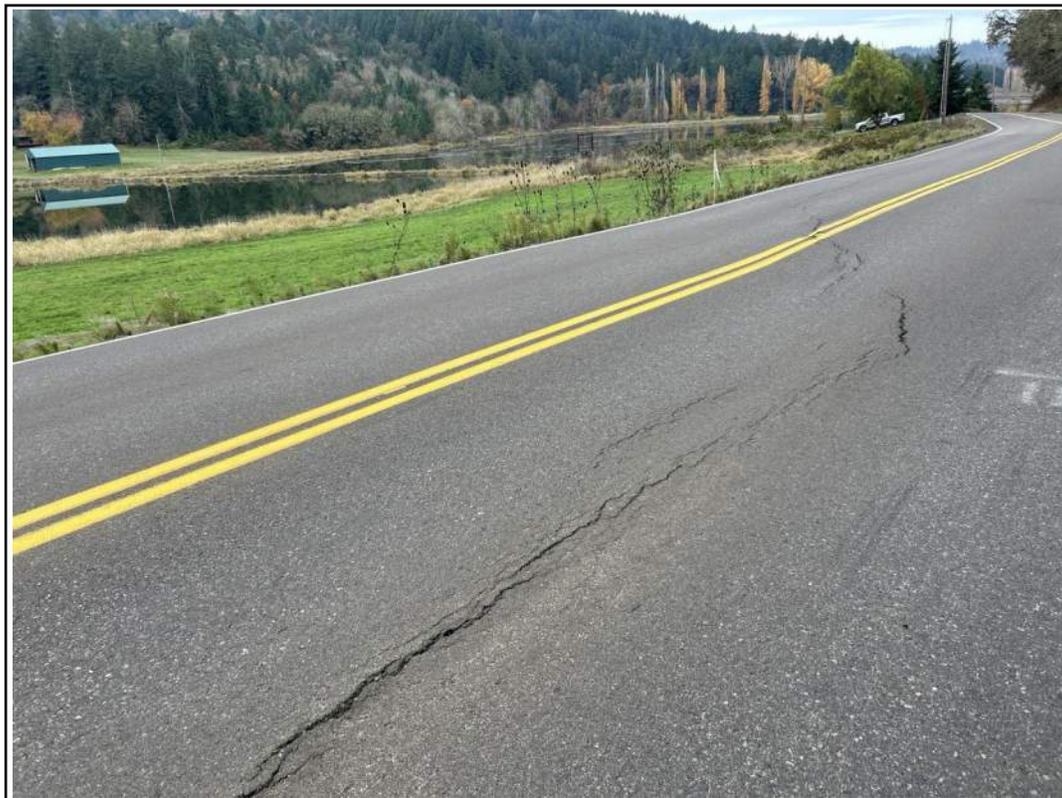
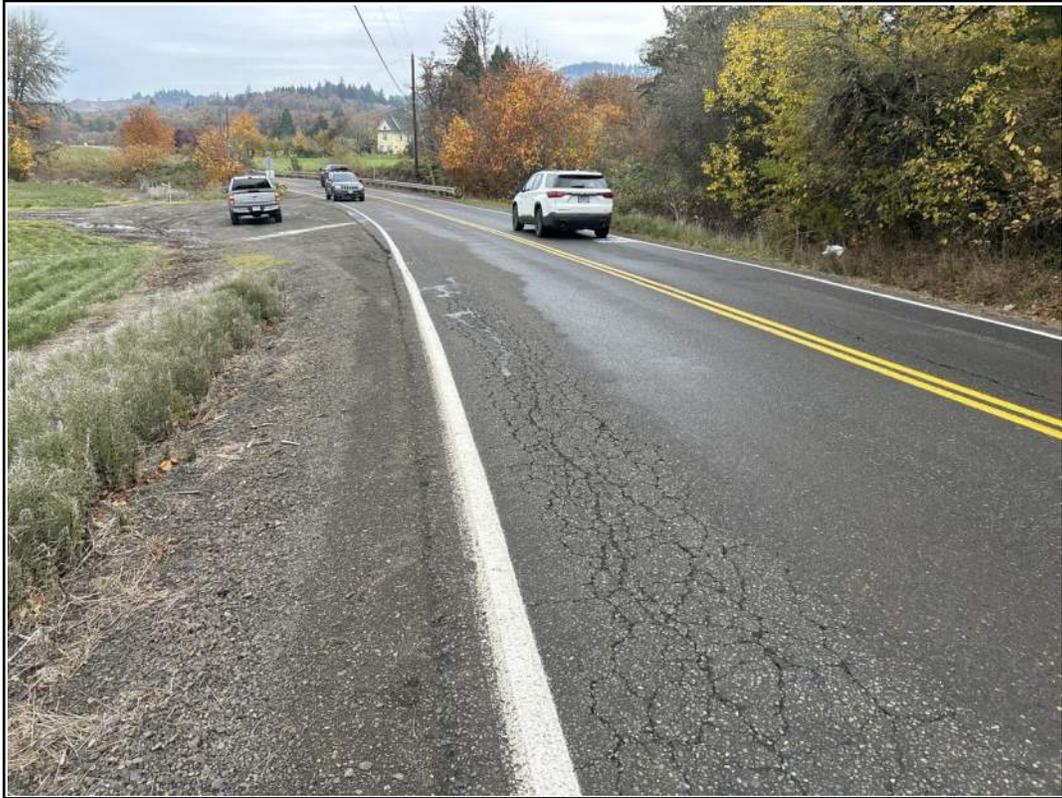
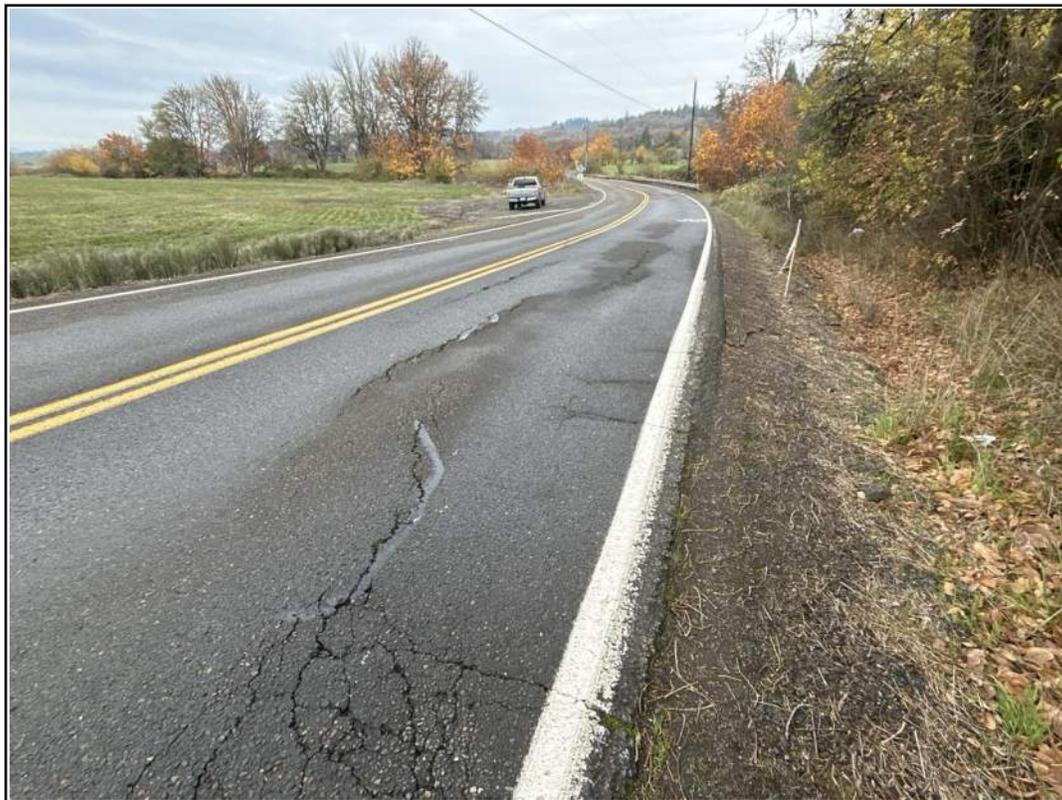
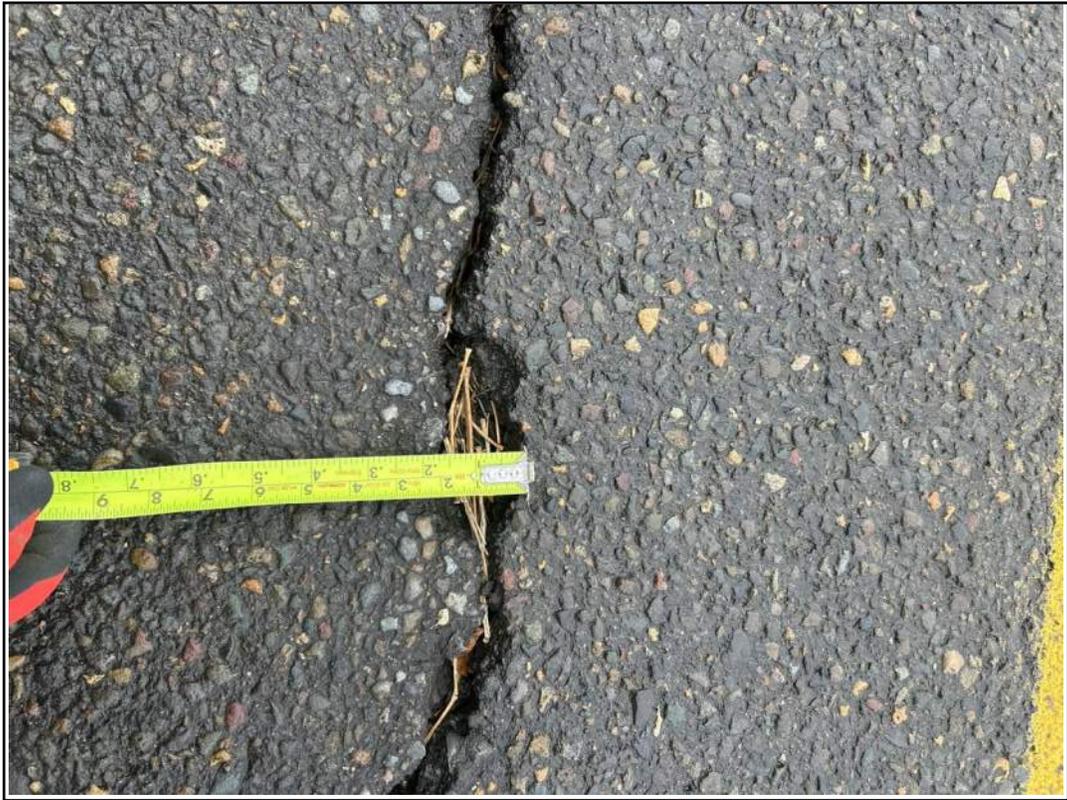
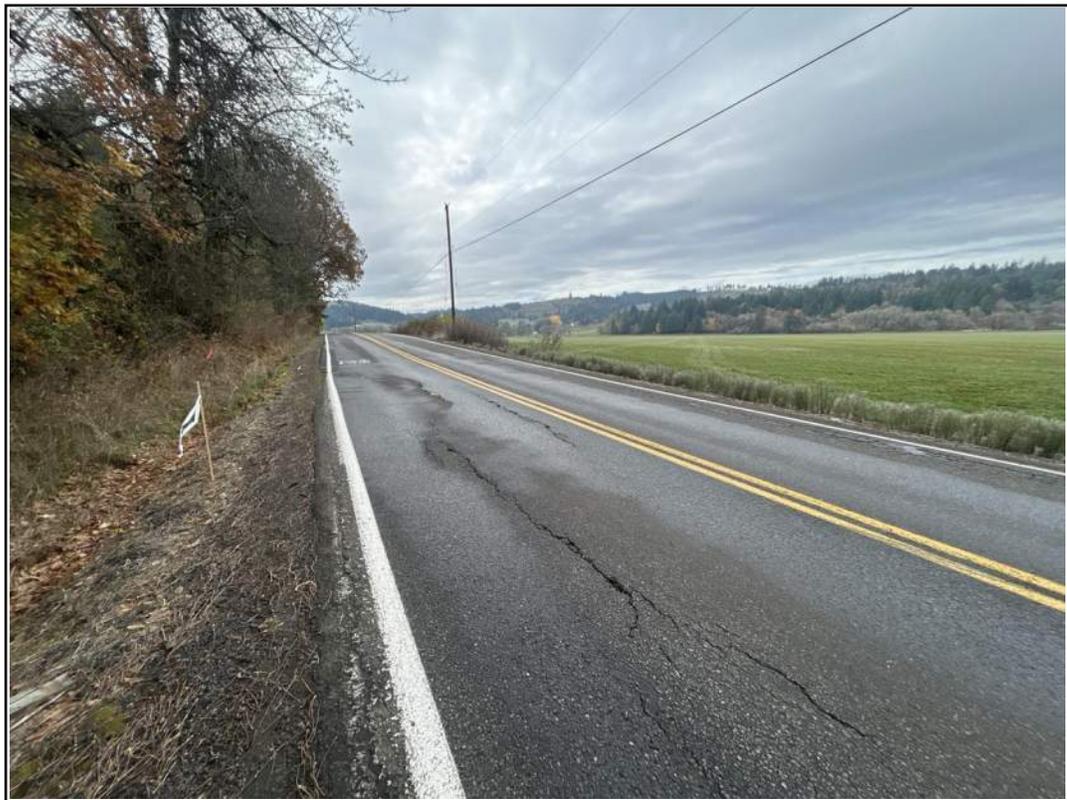
APPENDIX A: Pavement Distress Photographic Log

Pavement distress existing at the four uneven areas mainly consists of longitudinal cracks resulting from irregular ground deformations associated with the settlement and creep movement of landslide debris and fan deposits. Crack separations within the uneven areas were generally 2 to 3 inches wide at the time of this study. In addition to the horizontal separations, irregular vertical deformations exist throughout the uneven areas, combining for poor ride quality. A photographic log showing the pavement distress at each of the four uneven areas is presented in Appendix A.

With the intent of improving overall ride quality with the understanding that future deformations will occur in the uneven areas, we recommend reconstructing the pavement with double-layer geogrid reinforcement. Below is our recommended repair for the four uneven areas. Based on discussions with the County, rehabilitation and drainage improvements will be made throughout the project limits of North Valley Road. Therefore, the AC section below should be considered the long-term AC thickness after rehabilitation.
